Attack of the Clones

Recognize this? This is a discreet insulation displacement connector (IDC) manufactured by 3M. Or is it? It could be a clone manufactured in Asia. Knock-off connectors started showing up in the telephone industry many years ago. I'm sure that 3M is just one of many victims of knock-offs, and not just from Asia but anywhere in the world where they can make products for less and market them effectively. While some knock-offs are good quality, many aren't.

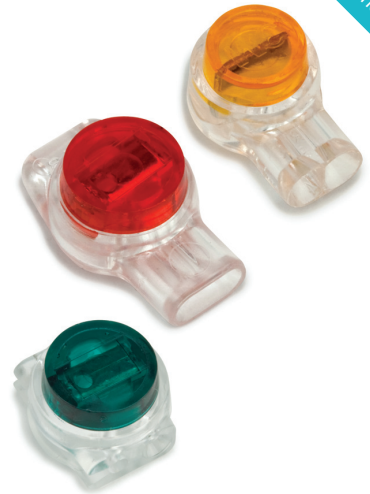
Recognize this? This is a discreet insulation displacement connector (IDC) manufactured by 3M. Or is it? It could be a clone manufactured in Asia. Knock-off connectors started showing up in the telephone industry many years ago. I'm sure that 3M is just one of many victims of knock-offs, and not just from Asia but anywhere in the world where they can make products for less and market them effectively. While some knock-offs are good quality, many aren't.

Troubleshooting in the field narrowed down the problem to both the feeder and distribution splices at the cross-connect box. Further testing proved the problem in the splice connectors themselves. There was absolutely no doubt that we were getting high resistance opens in the connectors themselves.

Our first thought was to ask ourselves what the vendors may have done in the name of COST SAVINGS to cheapen up their product to the point where it almost works like it used to work? I called the vendor, armed and ready to fire away. With my first question the person on the other end of the phone asked, "Can you see our logo clearly in the cap of the connectors you found?"

And guess what: I couldn't! The vendor's next statement was: "Welcome to the attack of the clones." While this example is about one vendor -- 3M -- but I'm sure it affects others.

Let me give you some info on ways to determine if you are looking at a clone or looking at the real thing. And in some cases it isn't easy. Look for the supplier logo and make sure it's the right supplier logo. If you are in any doubt about the quality and maybe even the origin of discreet connectors in your network, call your local vendor's representative sales contact. These folks are trained to help you, and they love helping solve a problem that wasn't created by their product in the first place!
